MOUNTING INSTRUCTIONS FOR PTO

021211075 for gearbox SCANIA GRSO 905
021211076 for gearbox SCANIA GR875/905 and GRS895/905
MOUNTING KIT : 021465006

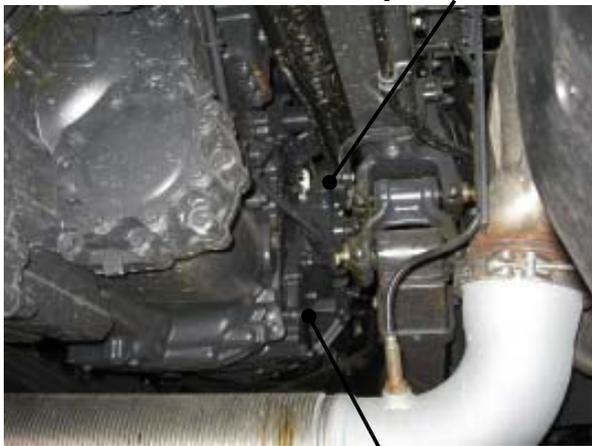
01

Preliminary operation: drain the oil from the gearbox. The picture shows the PTO attachment flange (A), and the clutch cylinder to be moved (B).

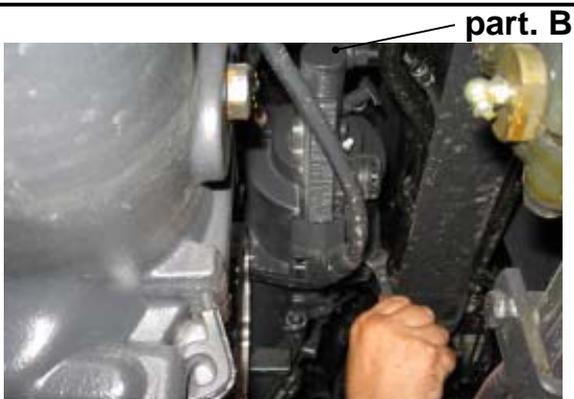
02

Remove the lower fixing screws of the clutch cylinder (B)

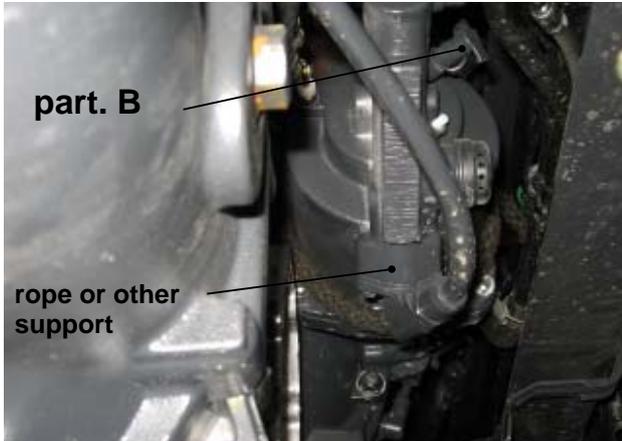
03

Positioning yourself in the upper part of the vehicle, in the work zone, take a rope (or other support) and pass it around the clutch cylinder. Then fix it momentarily to the frame stringer of the vehicle.

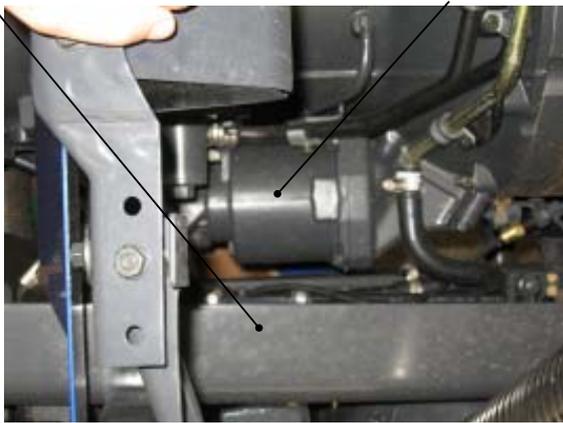
04

Seen from above there are a number of obstructions adjacent to the clutch cylinder (B) and frame stringer of the vehicle before starting the assembly procedures.

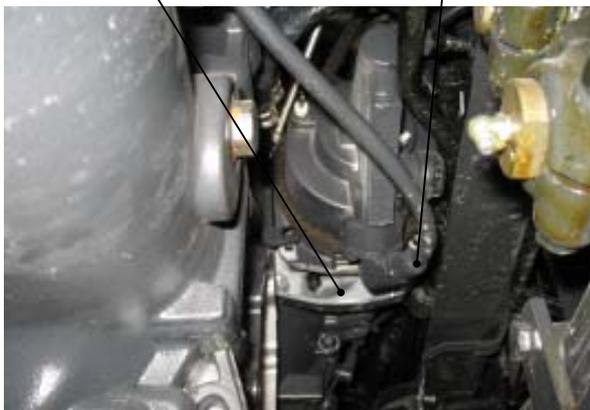
05

Unscrew the screws completely from the clutch cylinder and move it slightly (E), with great care, **DO NOT REMOVE IT COMPLETELY**. Turn the cylinder slightly, moving the obstruction of the tube (F), slowly

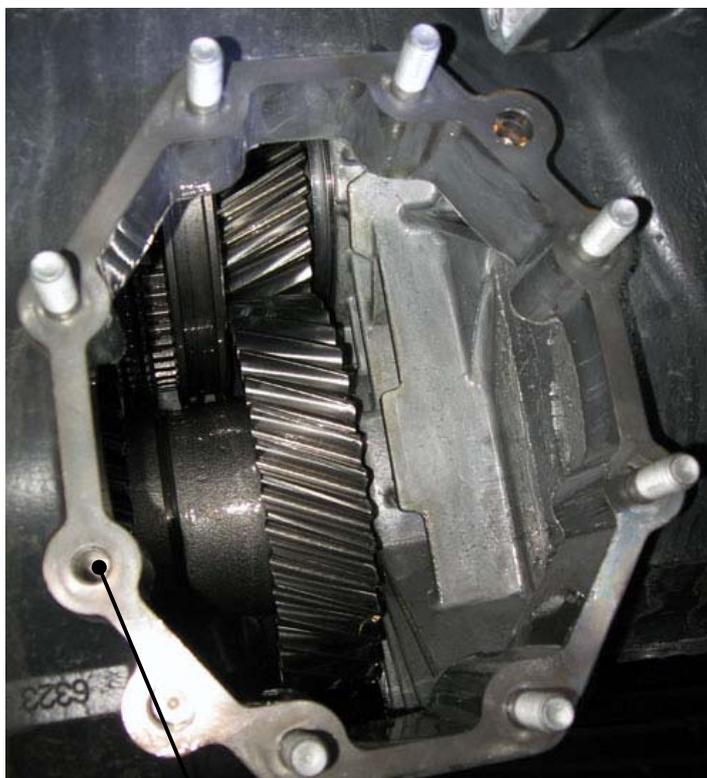
06

Remove the cover. Carefully clean the finished surfaces with a spatula or wire brush, taking care not to accidentally introduce foreign bodies into the gearbox. For this reason please fit the centering pins into the gearbox and NOT into the PTO, tightening them with Loctite.
In the point C please DO NOT fit the stud.

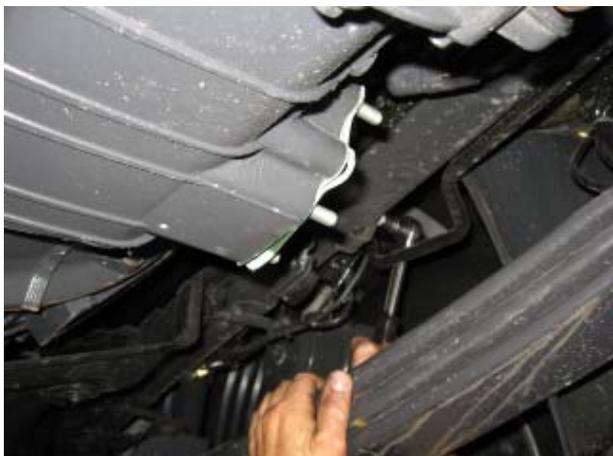
07

Add the gasket supplied.

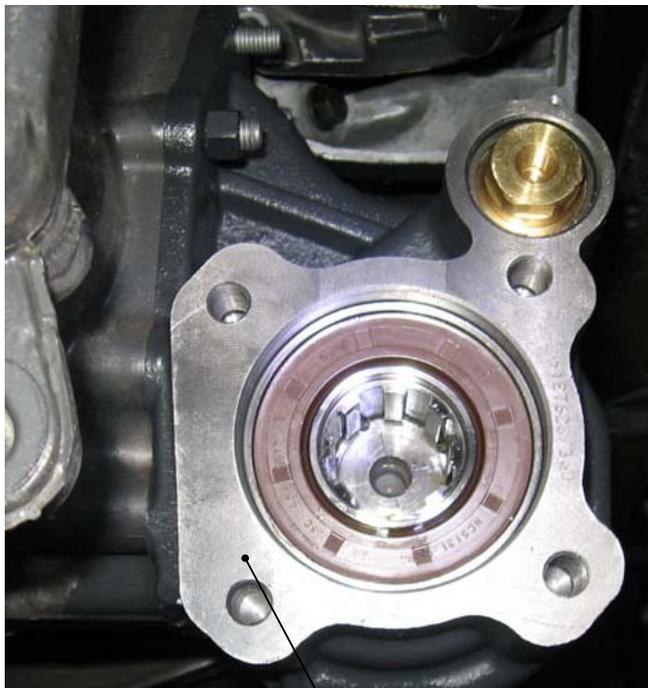
08

Assemble the PTO, being careful not to damage the gasket. In this operation the clutch cylinder is not in position. As soon as the fixing nuts of the PTO are tightened, loosen the support rope of the clutch cylinder and insert all its screws. Then remove the rope support and tighten the screws. Dismantle the lid to check the clearance on the PTO. Introduce the index finger into the hole and check, tilting the gear of the PTO slightly, so that there is sufficient clearance between this gear and that of the gearbox.

This value should be between 0.1 and 0.2 mm. Perform a few static manoeuvres of engagement and disengagement, to check that the assembly has been done correctly and unusual noises do not persist. If the PTO produces sibilant noise, this means the clearance is not sufficient; in this event, add a gasket. If, on the other hand, the PTO knocks, it is a sign that the clearance is excessive and the number of gaskets must be reduced.

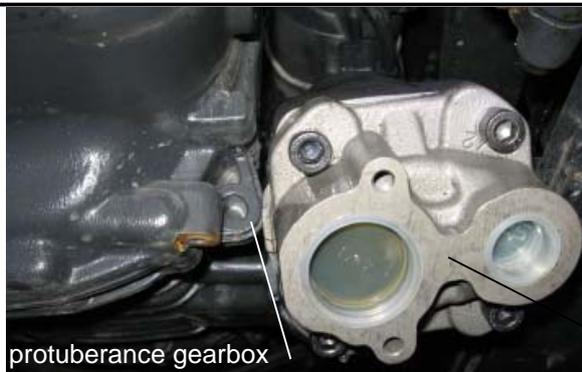
In case you use one of our pumps (pictures are showing our HDS and NPH... THIN ISO SHORT types) please take care that the gearbox tab (due to casting tolerances) does not interfere against the pump itself, jeopardizing in this case its correcting mounting, use and lifetime. If needed, please clear this interference by means of the most appropriate tools.
